BRITISHROWING

HRSA Monthly Report

June 2022

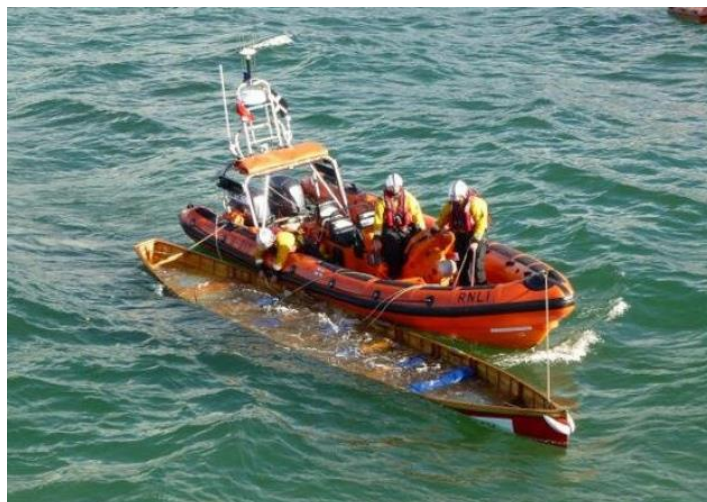
Please remember that although capsized and swamped wooden gigs do float, they do not provide sufficient buoyancy to keep their crews afloat. This is demonstrated in the photo opposite of a gig that capsized in a previous incident.

It is for this reason that I would recommend that everyone in a gig (or similar wide beamed rowing boat) on open water should wear a lifejacket.

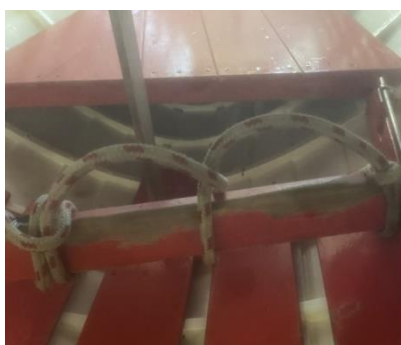
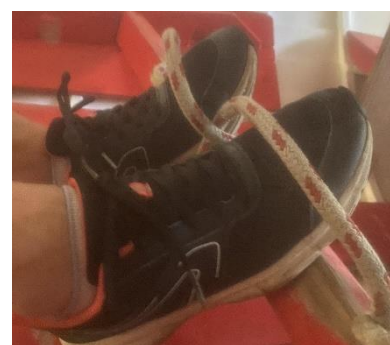
There was a suggestion that the rowers had their feet tied into the boat. This is not the case but they were using rope strops for the feet so that they did not fall backwards from the thwart at the end of the drive phase of a stroke. This configuration is shown in the photos opposite.

If the boat adjustments are correct for each rower, and if the rowing technique is correct, and the rower is sitting in the correct place in the seat, then this should not be necessary.
